THE M_w7.8 2016 KAIKŌURA EARTHQUAKE: SURFACE FAULT RUPTURE AND SEISMIC HAZARD CONTEXT

Mark W. Stirling¹, N. J. Litchfield², P. Villamor²,
 R. J. Van Dissen², A. Nicol³, J. Pettinga³, P. Barnes⁴,
 R. M. Langridge², T. Little⁵, D. J. A. Barrell², J. Mountjoy⁴,
 W. F. Ries², J. Rowland⁶, C. Fenton³, I. Hamling², C. Asher²,
 A. Barrier³, A. Benson⁵, A. Bischoff³, J. Borella³, R. Carne⁷,
 U. A. Cochran², M. Cockroft³, S. C. Cox², G. Duke¹, F. Fenton³,
 C. Gasston⁶, C. Grimshaw³, D. Hale³, B. Hall⁶, K. X. Hao⁸,
 A. Hatem⁹, M. Hemphill-Haley^{10,13}, D. W. Heron², J. Howarth²,
 Z. Juniper², T. Kane⁴, J. Kearse⁵, N. Khajavi³, G. Lamarche⁴,
 S. Lawson², B. Lukovic², C. Madugo^{11,13}, I. Manousakis^{12,13},
 S. McColl⁷, D. Noble³, K. Pedley³, K. Sauer¹, T. Stah¹³,
 D. T. Strong², D. B. Townsend², V. Toy¹, M. Villeneuve³,
 A. Wandres³, J. Williams¹, S. Woelz⁴ and R. Zinke⁹

ABSTRACT

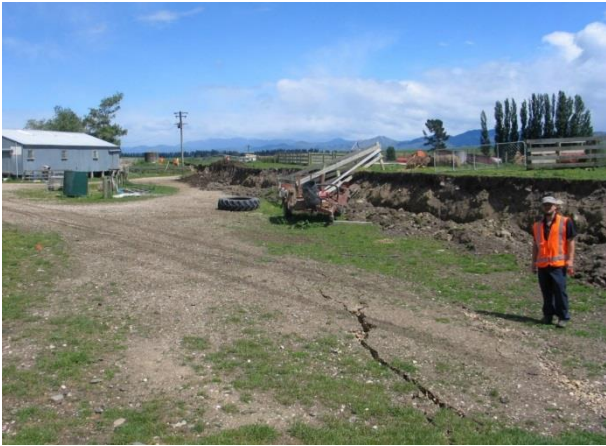
Figure 3: Oblique dip slip-dextral fault scarp of The Humps Fault at Glenbourne Farm that caused displacement damage to concrete slabs, farm tracks and fencing (Lat 42.615°S, Lon 173.105°E; view west; photograph by Jarg Pettinga).

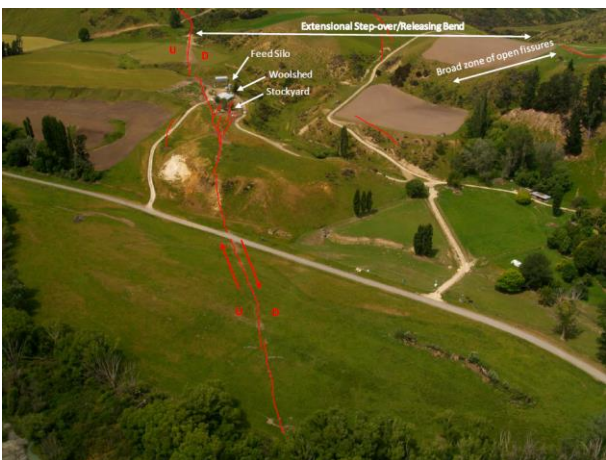
Figure 4: Aerial view of The Humps Fault surface rupture (red lines) at Glenbourne Farm, showing the sense of movement (red arrows) and highlighting farm infrastructure damaged by the earthquake (Lat 42.615°S, Lon 173.105°E; view northeast; photo and annotation by Clark Fenton).

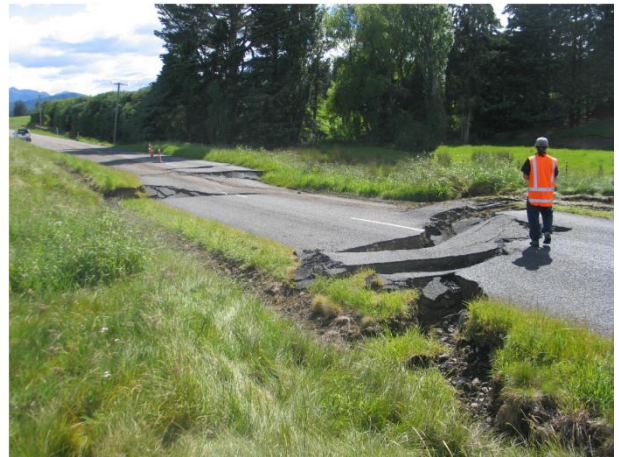
Figure 5: Oblique transtensional rupture within The Humps Fault zone displacing State Highway 70 (the Inland Kaikōura Road; Lat 42.597°S, Lon 173.091°E; view towards the north; photograph by Jarg Pettinga).

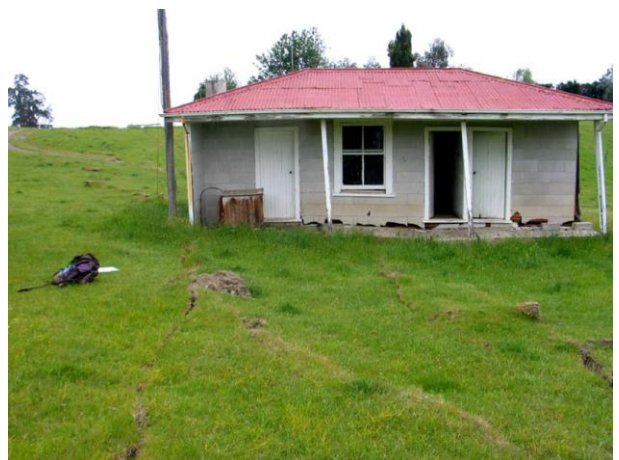
Figure 6: The Humps Fault surface rupture through a farm worker's cottage at Hossack Downs (Lat 42.629°S, Lon 173.015°E; photograph by Jarg Pettinga).

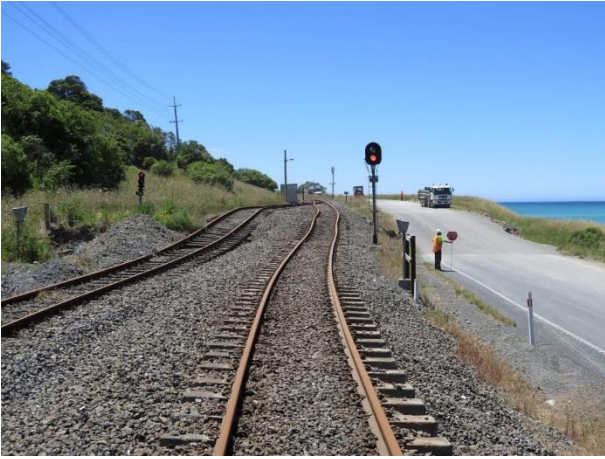
Figure 7: Dextral-reverse displacement of the SIMT and State Highway 1 across the Hundalee Fault at Oaro (Lat 42.504°S , Lon 173.510°E). The displacement of the road was sharp, but smoothing and resurfacing was just being completed when the photo was taken. The SIMT offset was diffused through embankment ballast and the flexibility of the rails, and in this view has yet to undergo any repair or modification (photograph by Mark Stirling).

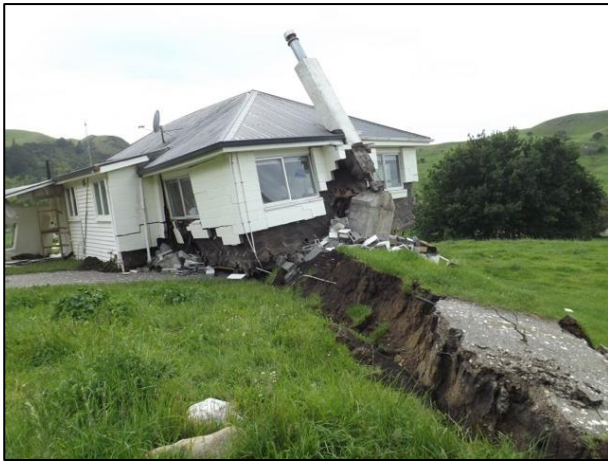
Figure 8: Direct fault surface rupture of c.8 m (dextral) through a farm worker's house across the Kekerengu Fault (Lat 41.978°S , Lon 178.998°E ; view to the west; photograph by Tim Little).

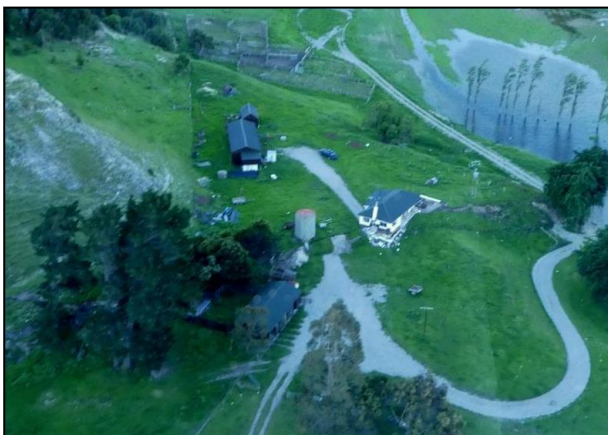
Figure 9: Aerial view of the area of the Kekerengu Fault rupture shown in Figure 8 (view to the north; photograph by Tim Little).

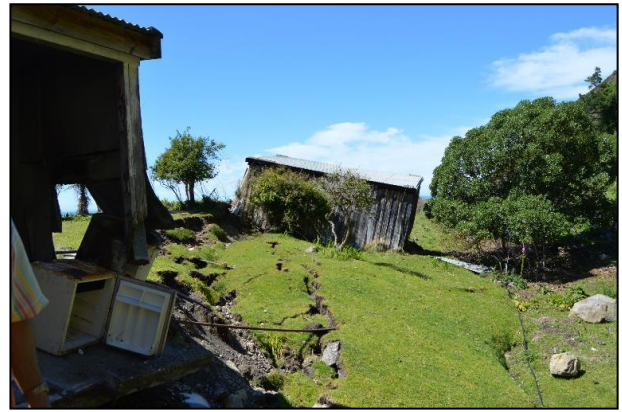
Figure 10: Rupture through farm buildings on a southwestern stand of the Papatea Fault near the coast (Lat 42.201°S , Lon 173.875°E ; view to the south; photograph by Robert Zinke).

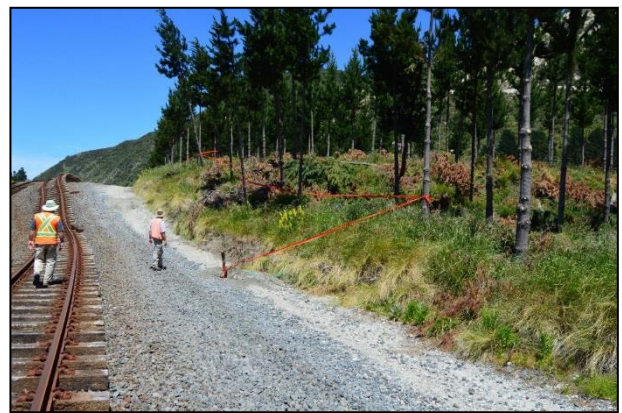
Figure 11: Surface fault rupture across a northeastern strand of the Papatea Fault near the coast deformed and distorted the SIMT line and severed the East Coast fibre optic cable at this location. Orange flagging marks the location where the fibre optic cable was cut by fault rupture and subsequently repaired (view to the southwest; photograph by Robert Zinke).

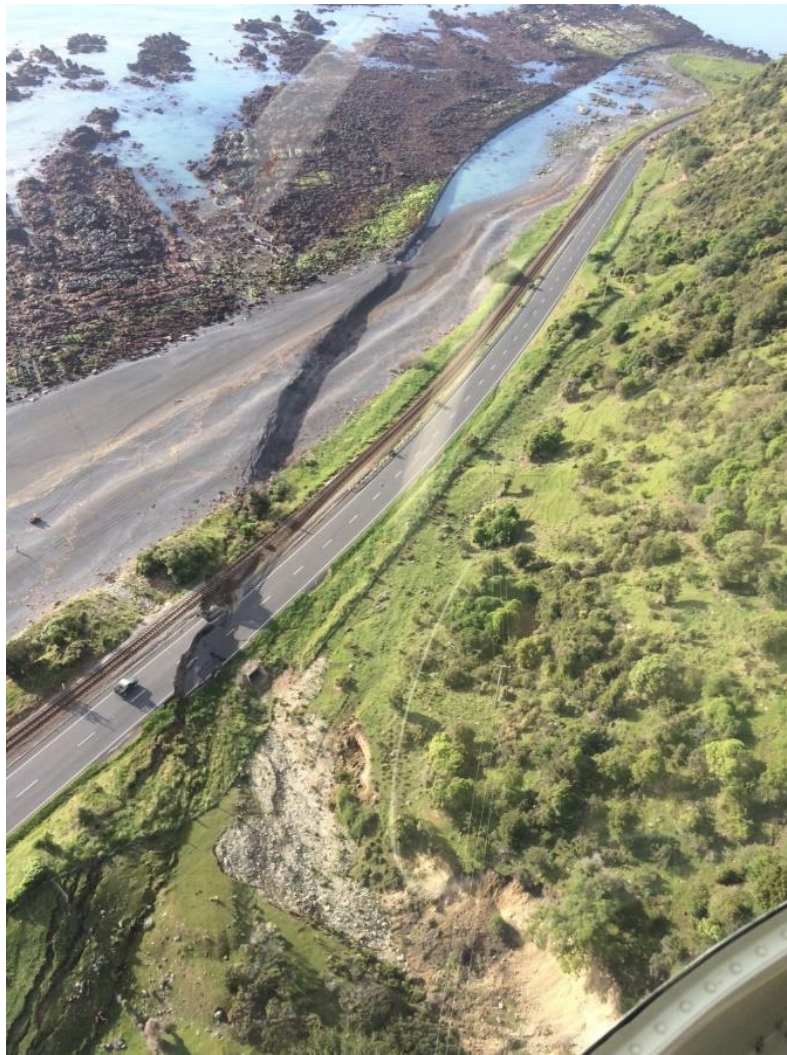
Figure 12: Aerial view of a southwestern strand of the Papatea Fault surface rupture across State Highway 1 and the SIMT line. This scene lies about 100 m south of that shown in Figure 10 and 900 m southwest of the Figure 11 view of the northeastern strand of the fault (view to the south; photograph from Chris Hayles).

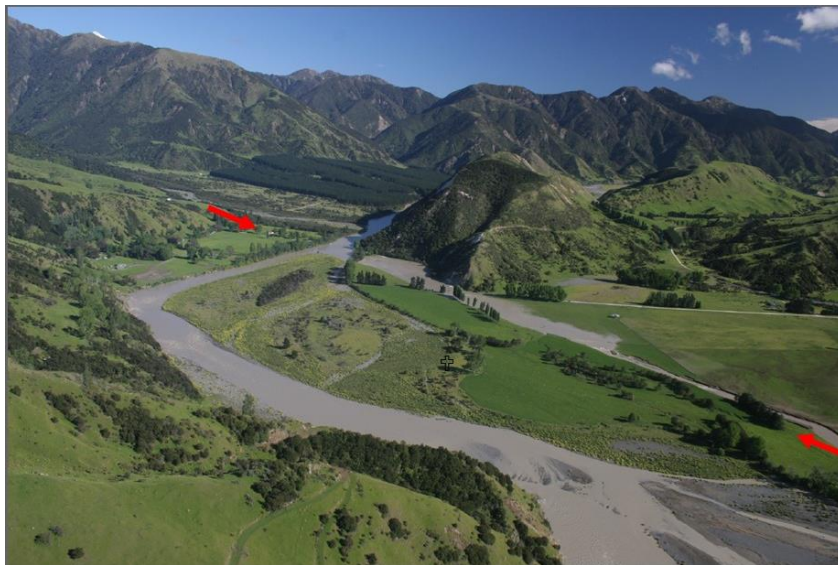
Figure 13: Avulsion of the Clarence River onto farmland as a result of displacement along the Papatea Fault (Lat 42.115°S, Lon 173.844°E). The obvious distributary of the river to left of centre has occurred as a result of oblique-sinistral slip and formation of a zone of echelon folding and faulting (west side up) between the arrows and across the river (view to the northwest; photograph by Julie Rowland).
