LANDSLIDES CAUSED BY THE MW7.8 KAIKŌURA EARTHQUAKE AND THE IMMEDIATE RESPONSE

ABSTRACT

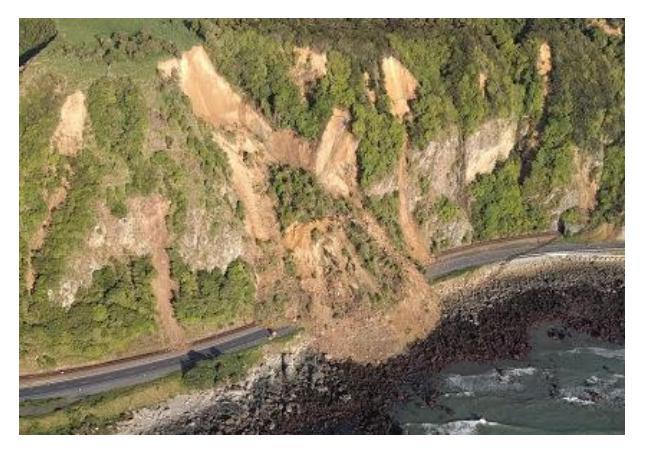
Between Waipapa Bay and Mangmaunu at the Mouth of the Clarence River in the north, to the mouth of the Hapuku River in the south, State Highway 1 and the main trunk railway line was completely inundated by debris from large landslides in several places (Figure 2). After stopping briefly in Kaikōura the reconnaissance continued, travelling south and observing State Highway 1 and the main trunk railway line again being blocked in several places by large landslides between Peketa and Oaro. Continuing south along the coast, landslides were prominent on the coastal cliffs as far south as Goose Bay (Figure 3).

Figure 2: Landslide blocking the railway line and State Highway 1 north of Kaikōura. The landslide has broken the railway line and dragged the tracks across the road on the right hand side of the photo. The coastal uplift at this site is also visible in the exposed shoreline covered with sub-tidal seaweed. (Photo: S. Dellow 14/11/2016).

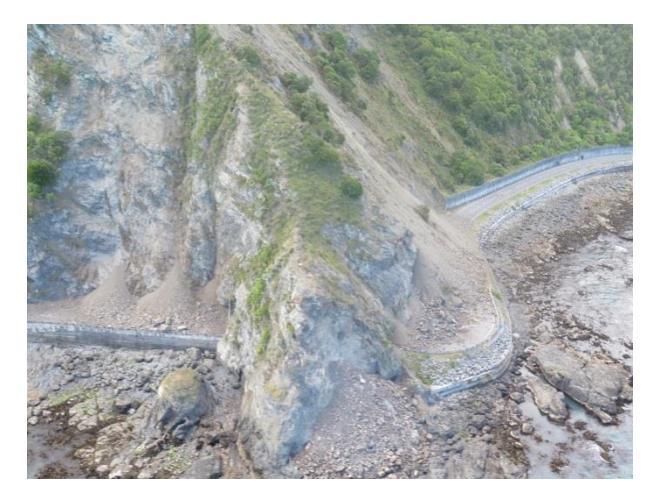
Figure 3: Landslides on either side of the Paratatahi Tunnels, State Highway 1, south of Kaikōura. The railway line at this location is enclosed in a rock shelter, and so was not directly affected. (Photo: S. Cox, 20/11/2016).

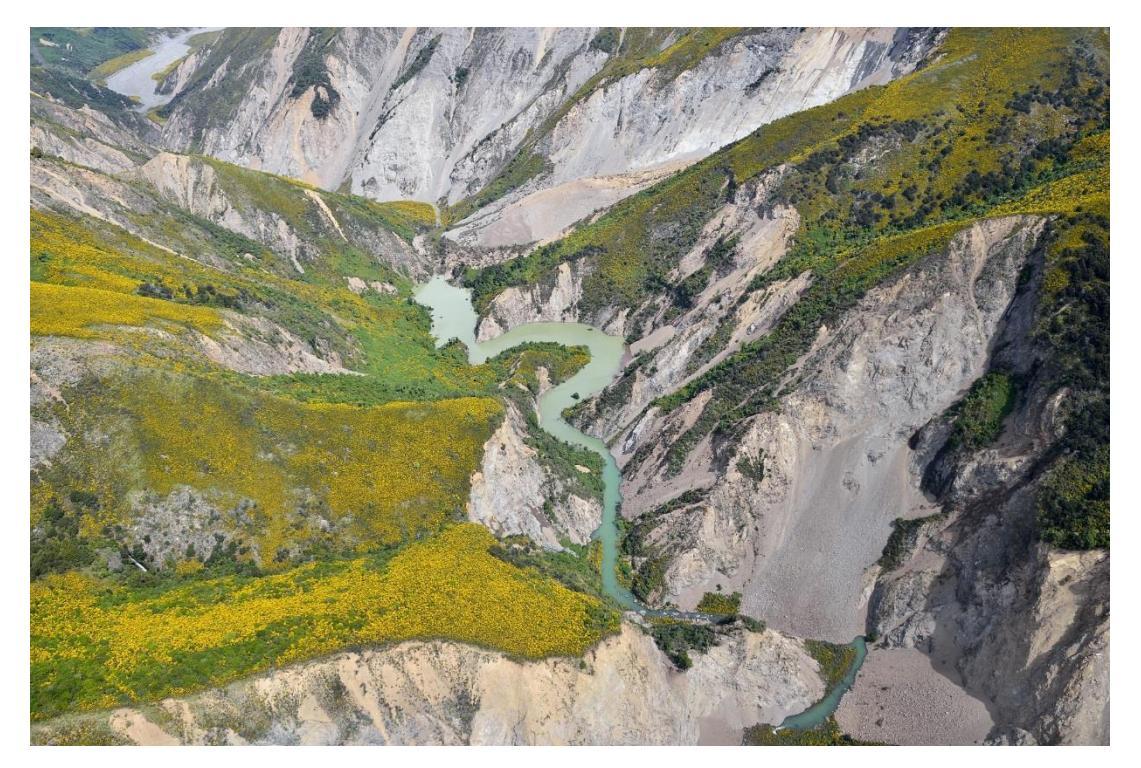
Figure 4: Landslide dams in the upper reaches of the Conway River in the Seaward Kaikōura Ranges. Two landslide dams are visible in the photo with water still impounding behind both. The source material for the landslides is Torlesse Greywacke which typically forms disrupted rock slides because of the closely jointed and fractured nature of the source rock mass. The resulting debris can be described as an angular gravel and is highly permeable. As a result, none of the large greywacke derived landslides overtopped under non-flood conditions, but developed flows through the permeable material forming the dam. (Photo: D. Townsend, 16/11/2016).

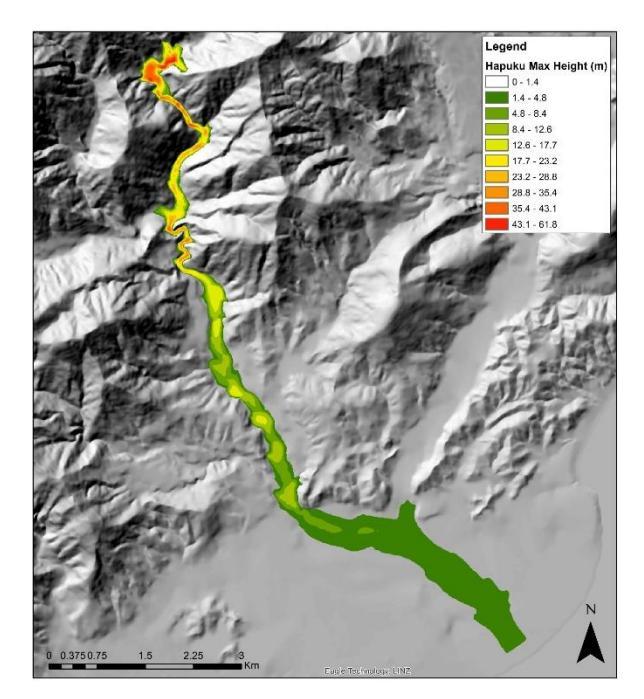
Figure 5: RAMMS modelling of the flow heights from rapid failure of the Hapuku landslide dam. Model parameters include a dam height of 80 m, dam width of 230 m; total volume of flow of 3 x 10⁶ m³; and a maximum discharge of 13,000 m³/s. Even with good data a range of scenarios is possible. This model run depicted the maximum credible flow height from rapid dam failure.

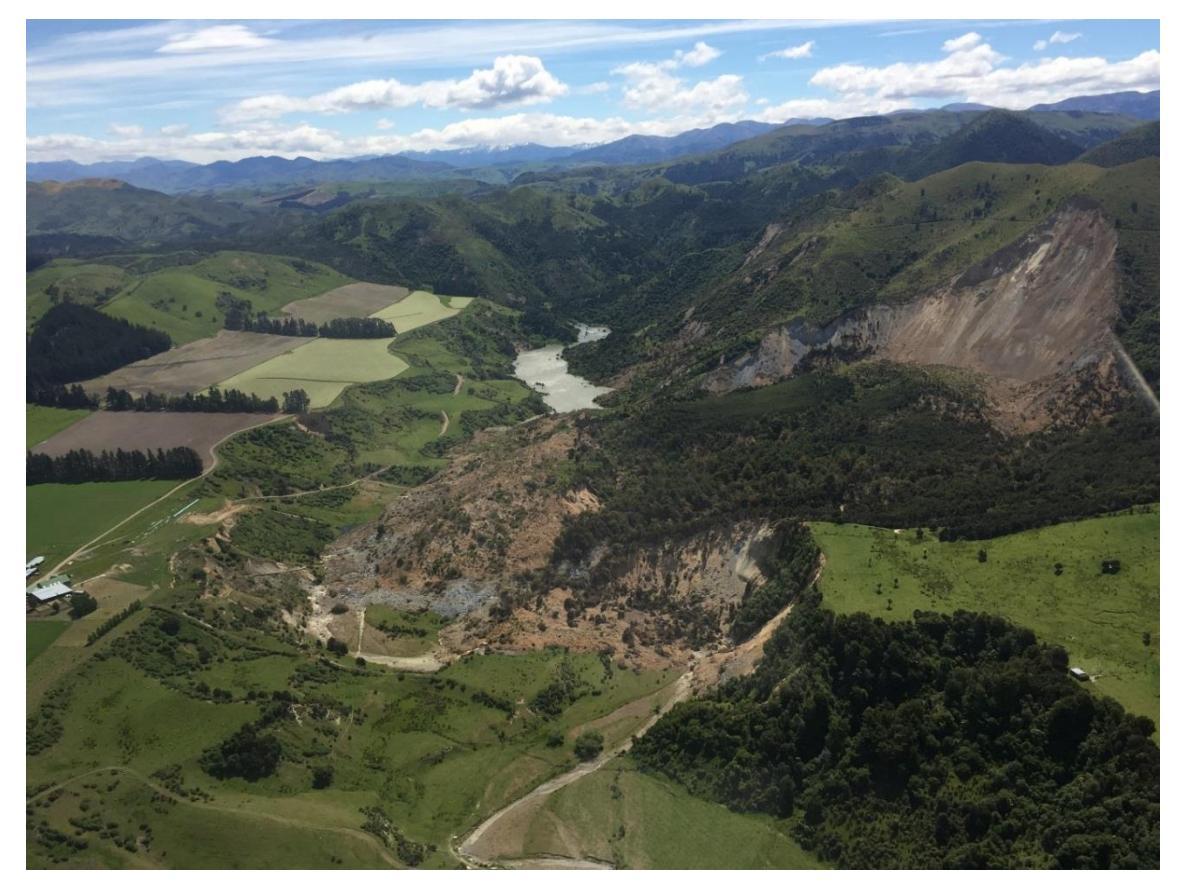
(Figure 6). First time rock and debris avalanches with strong structural geological controls, were the dominant landslide type in the basement materials (Figure 7). This led to two quite distinct types of landslide dam. The weak rocks failed as large block slides and slumps and, compared to the strong rock dams, were relatively impervious. In contrast, the landslide dams formed from strong source rocks were effectively piles of porous angular gravels where piping of water flows through the dam is readily apparent. How these two very different styles of landslide dam perform over the coming months and years is of interest because of the ability this has to inform landslide dam assessment after future earthquakes. As of the 12th May 2017 only one of the large, strong source rock dams remain (on the Hapuku), the others having breached during annual flood flows generated by heavy rainfall in early April 2017. Both of the large weak rock dams on the Stanton and Leader rivers are still intact (Stanton River) or partially intact (Leader River).

Figure 6: Landslide dam on the Leader River shortly after the earthquake. The landslide is a slump/block slide in a siltstone unit and is characteristic of the large landslides in weak Neogene rocks. The landslide dam overtopped and partially breached on the 13-14 February 2017 (Environment Canterbury).

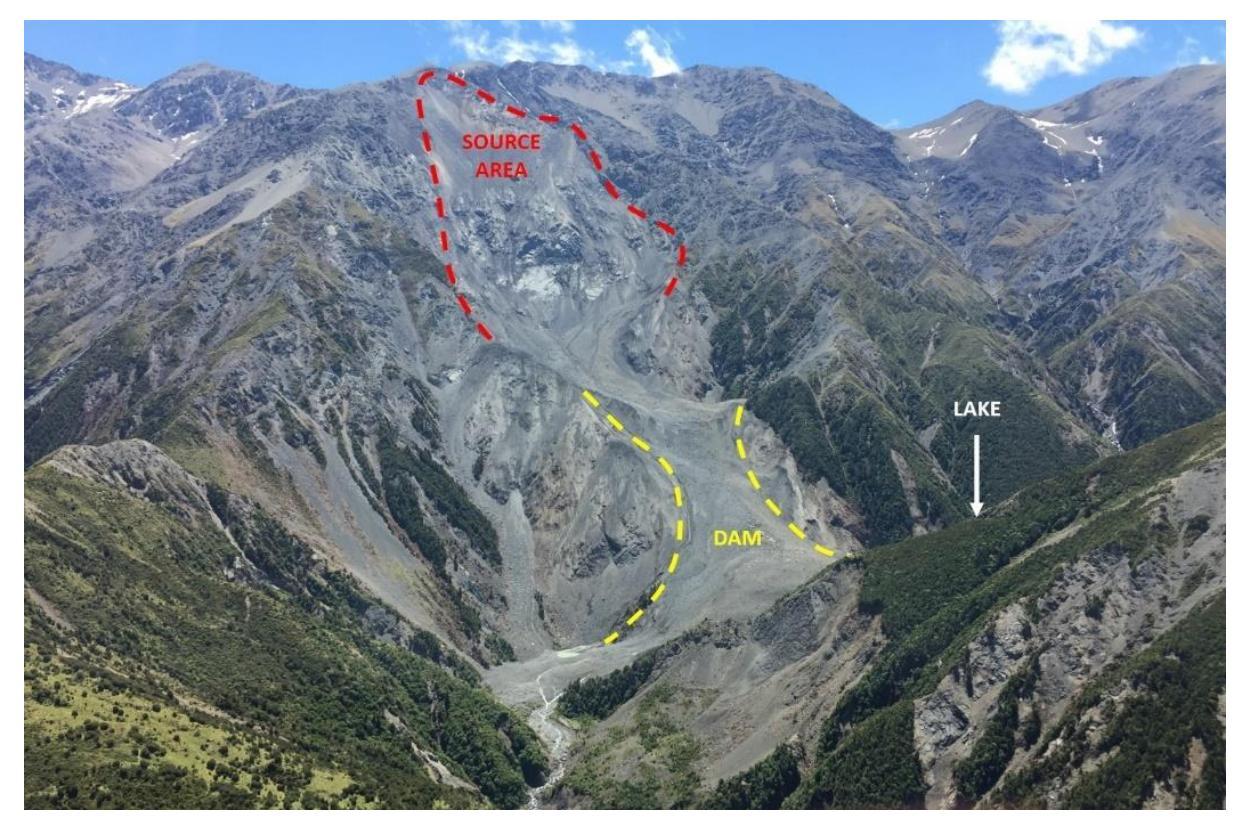
In one case, the largest landslide dam in the upper reaches of the Hapuku River (Figure 7), the terrestrial laser scanning process has been repeated three times. This showed that the landslide dam itself was slowly deforming (lowering at the crest by a nearly one metre over a period of nearly four months and bulging at the toe, again by a nearly one metre).

Figure 7: Hapuku River Landslide dam showing source area, landslide dam and valley downstream of dam. The landslide is a rock avalanche with a horizontal distance between top of the source area and the toe of the debris of 2.7 km. The volume of material in the landslide dam is estimated at $12 (\pm 2) \times 10^6 \text{ m}^3$. This is an example of a greywacke dam with internal flows readily apparent as seepage discharges near the toe of the dam on the downstream face.

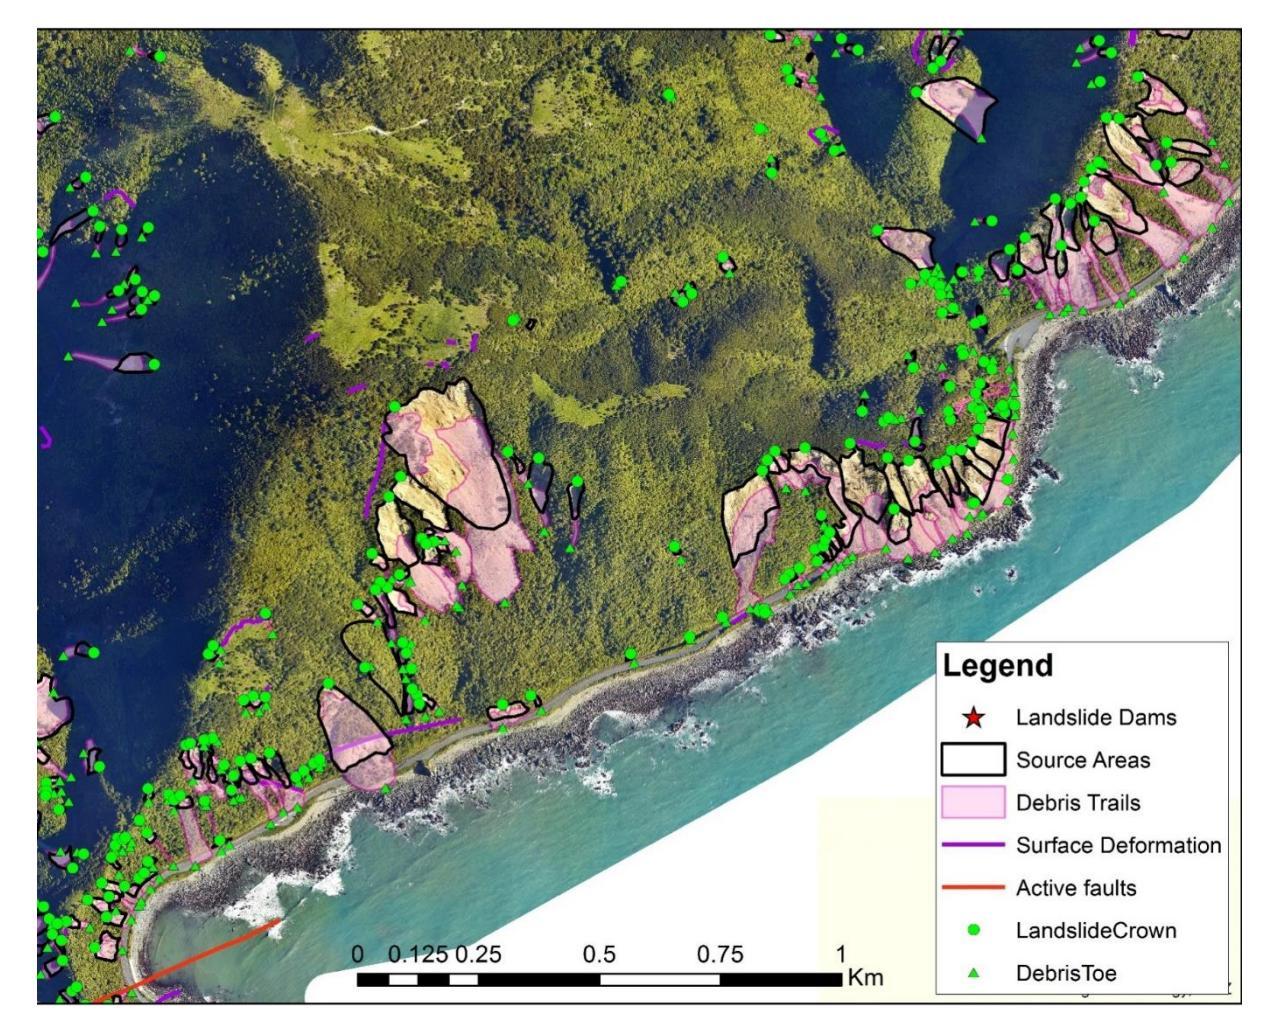
The data will be useful for recognizing immediate hazards (potential for failures/reactivations; Figure 8), outburst floods (dam breaches), short- to longer-term potential for debris flow and valley floor aggradation impacts, sediment budgets for catchments, and for assessing landslide causes (i.e. relationships with topography, geology, fault structures, shaking; Figure 9). One of the main uses of this data will be to assess how slopes performed in particular rock and soil (material) types during the earthquake. This data will be especially useful for those similar-sized slopes in Wellington, where much of the city is formed in similar materials (greywacke sandstones and argillites) to those forming the slopes in the albeit more mountainous. Kaikoura region. Such data will allow us to better constrain the response of the Wellington slopes to strong shaking e.g. a Wellington Fault earthquake.

Figure 8: An example of landslide inventory mapping on the coast north of Kaikōura. The large landslides in the centre left of the photo did not reach the foot of the slope and the debris is a hazard that could remobilize in an aftershock or rainstorm and will present an ongoing risk to road and rail users if mitigation measures are not determined and implemented.
