LANDSLIDES CAUSED BY THE MW7.8 KAIKŌURA EARTHQUAKE AND THE IMMEDIATE RESPONSE

ABSTRACT

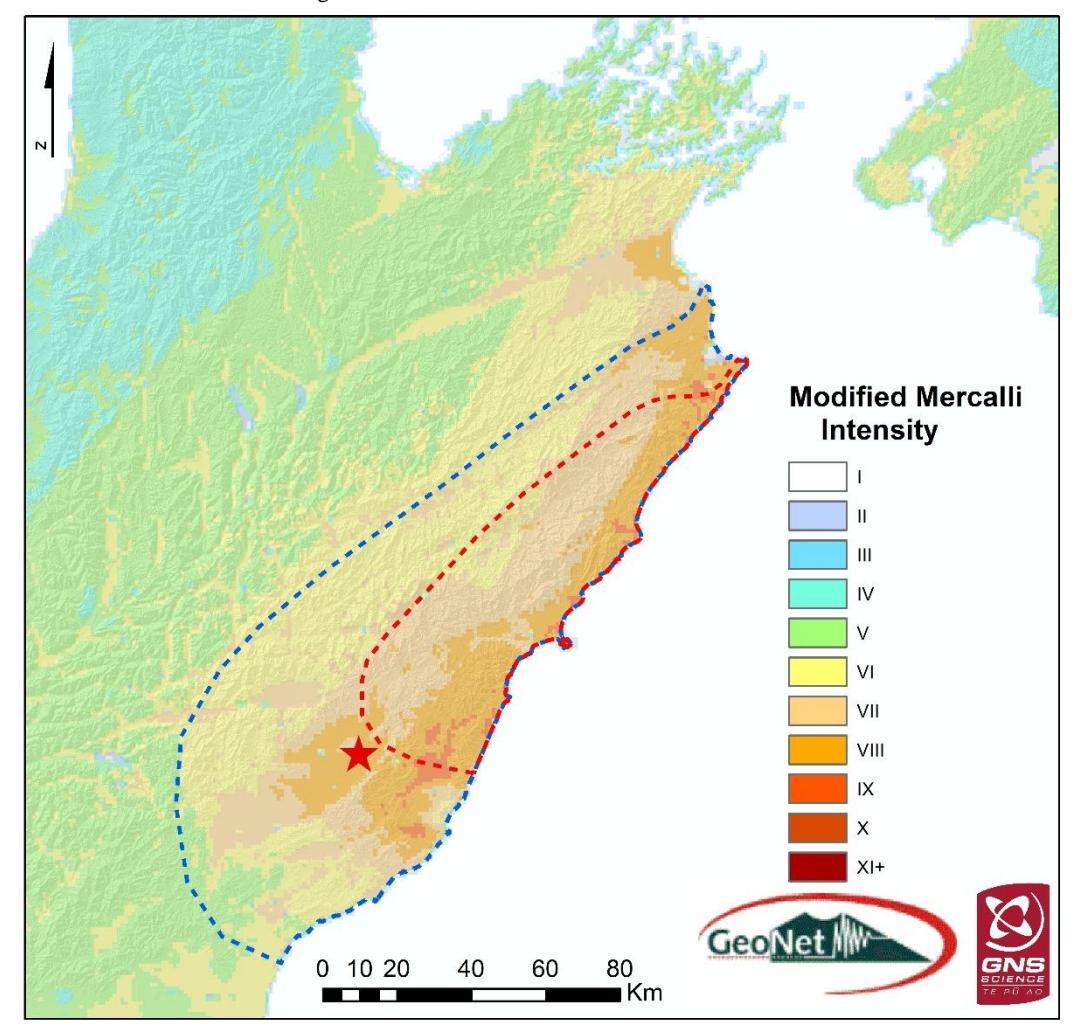
Figure 1: The 14th November 2016 M_W7.8 Kaikōura Earthquake. The epicentre is shown by the red star in the south of the map. The colours depict the Modified Mercalli Shaking Intensity, with MM VIII in the worst affected areas with isolated pockets of MM IX where deep soils are present. The areas of no landslide damage; light to moderate landslide damage (blue dash), and severe landslide damage (red dash) are shown. The severity of the landslide damage corresponds well with the strength of ground shaking in areas of hills and mountains. (Map credits: MMI - Nick Horspool; Landslide observations - Dougal Townsend).

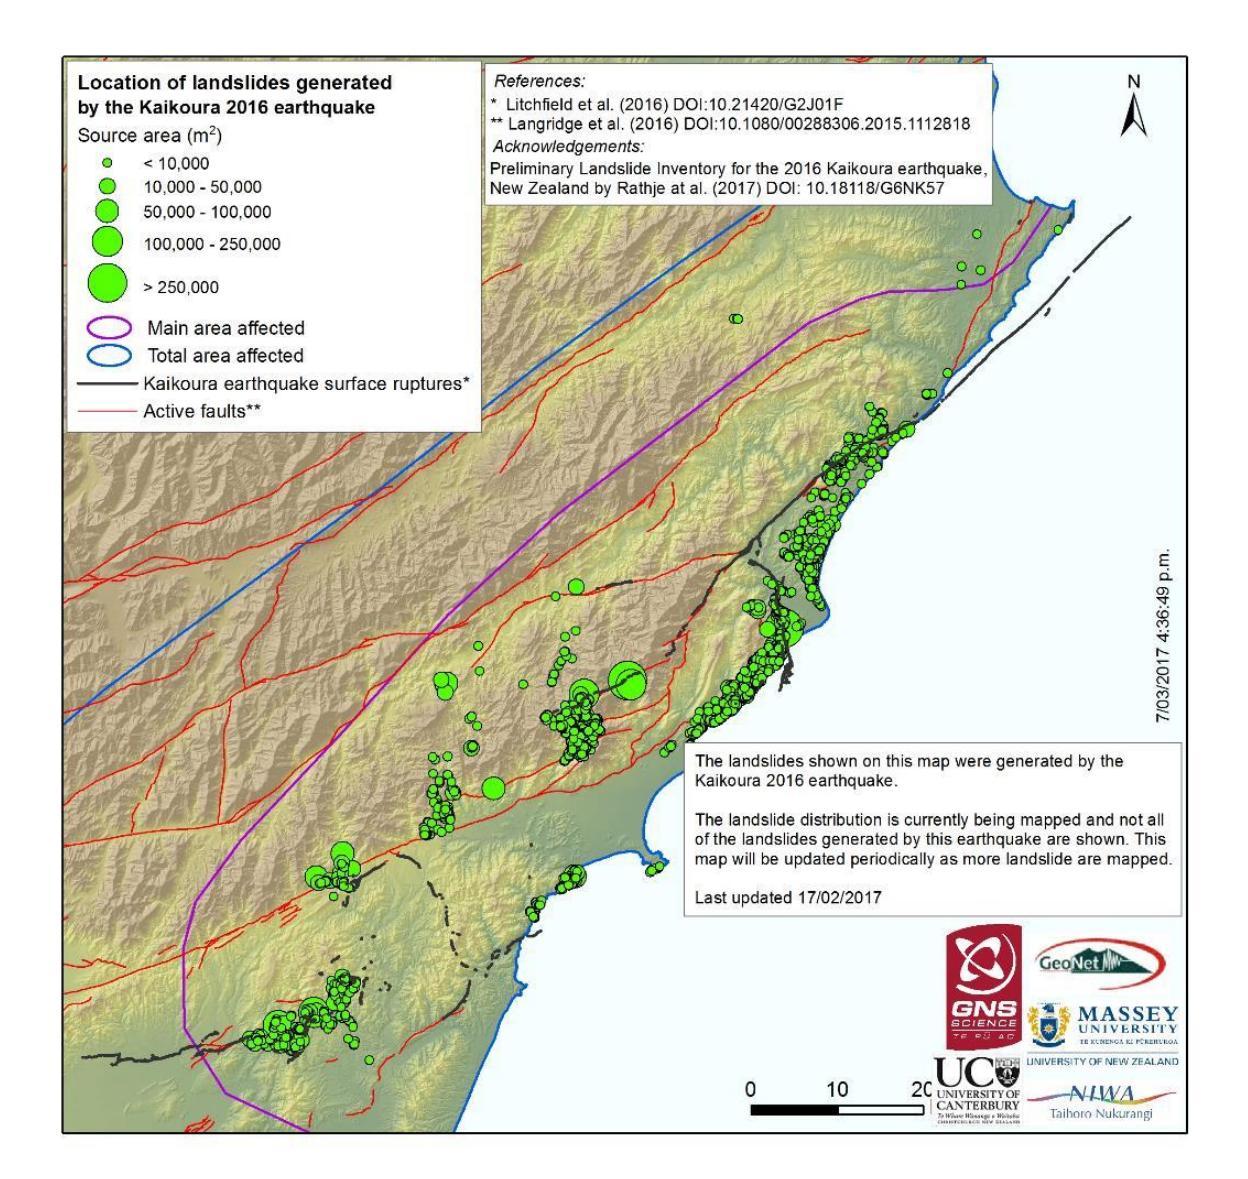
Figure 9: The landslide inventory for the 14 November 2016 M_W7.8 Kaikōura earthquake as at 17 February 2017 (estimate 30% complete). The active fault ruptures cause by the earthquake are shown as black lines on the map. The landslides, and particularly the largest landslides cluster around the fault ruptures.
