THE M_w7.8 2016 KAIKŌURA EARTHQUAKE: SURFACE FAULT RUPTURE AND SEISMIC HAZARD CONTEXT

Mark W. Stirling¹, N. J. Litchfield², P. Villamor²,
 R. J. Van Dissen², A. Nicol³, J. Pettinga³, P. Barnes⁴,
 R. M. Langridge², T. Little⁵, D. J. A. Barrell², J. Mountjoy⁴,
 W. F. Ries², J. Rowland⁶, C. Fenton³, I. Hamling², C. Asher²,
 A. Barrier³, A. Benson⁵, A. Bischoff³, J. Borella³, R. Carne⁷,
 U. A. Cochran², M. Cockroft³, S. C. Cox², G. Duke¹, F. Fenton³,
 C. Gasston⁶, C. Grimshaw³, D. Hale³, B. Hall⁶, K. X. Hao⁸,
 A. Hatem⁹, M. Hemphill-Haley^{10,13}, D. W. Heron², J. Howarth²,
 Z. Juniper², T. Kane⁴, J. Kearse⁵, N. Khajavi³, G. Lamarche⁴,
 S. Lawson², B. Lukovic², C. Madugo^{11,13}, I. Manousakis^{12,13},
 S. McColl⁷, D. Noble³, K. Pedley³, K. Sauer¹, T. Stah¹³,
 D. T. Strong², D. B. Townsend², V. Toy¹, M. Villeneuve³,
 A. Wandres³, J. Williams¹, S. Woelz⁴ and R. Zinke⁹

ABSTRACT

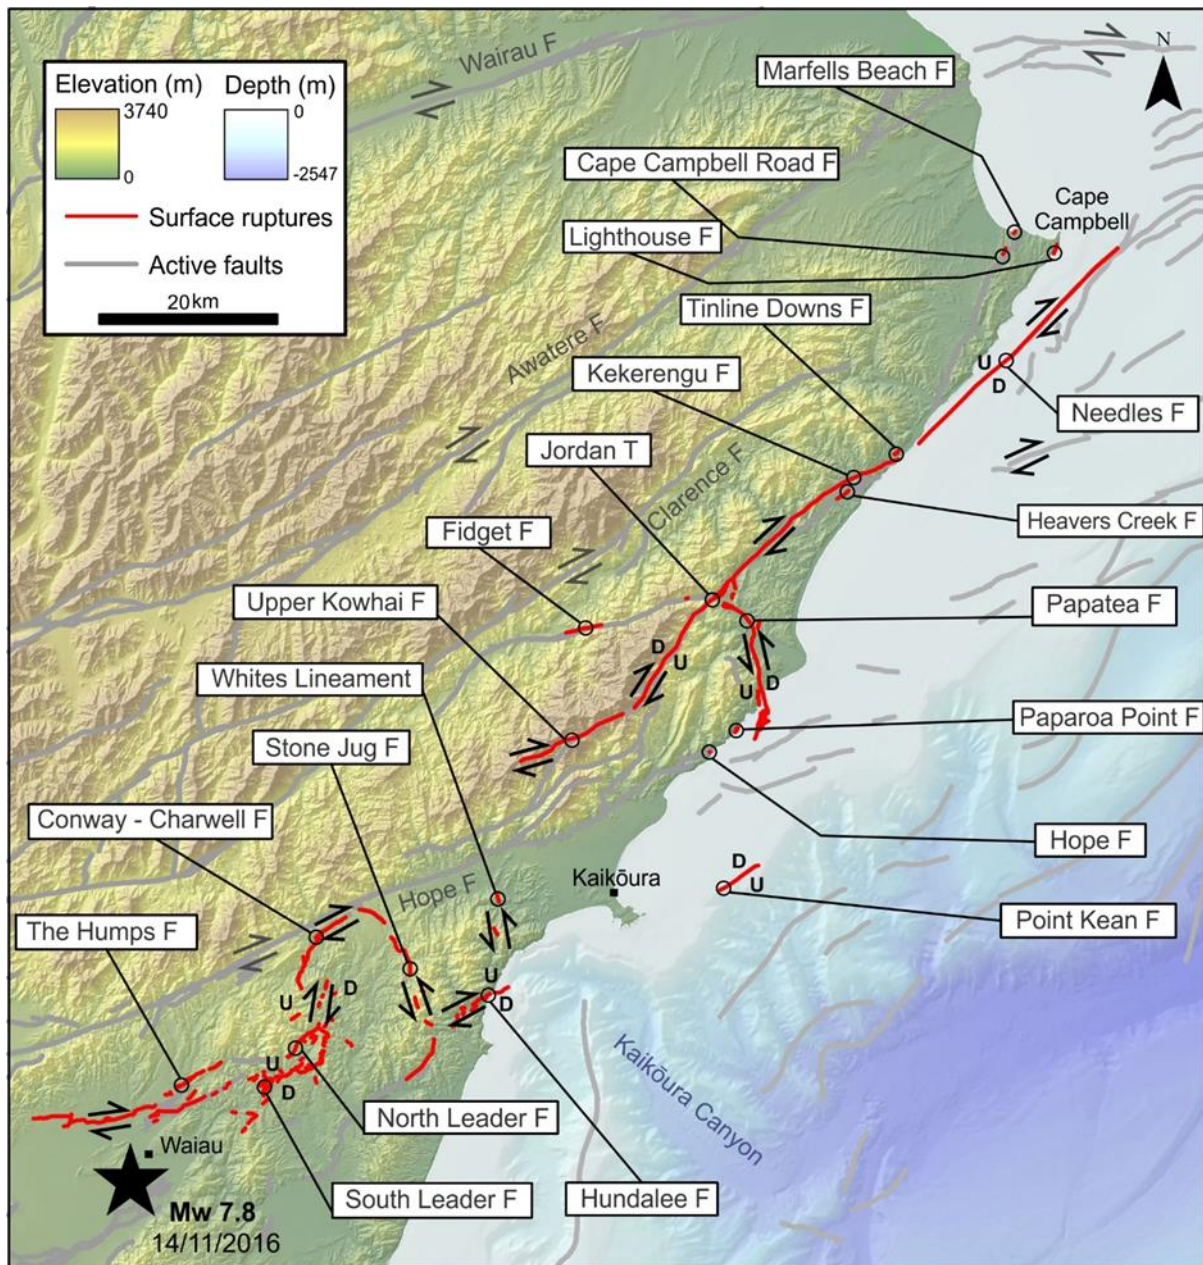
The $M_w 7.8$ Kaikōura earthquake was associated with a complex array of surface ruptures that involved at least 21 faults. Many were already mapped as active faults or geological faults prior to the earthquake, although some specific surface traces were previously unknown [21]. The earthquake ruptured the entire mapped lengths of some faults,

and the partial lengths of others [5]. In the following, brief descriptions of the surface fault ruptures, sorted into the 13 geographic fault zones defined by the various mapping teams from southwest to northeast are provided (Figure 2). We also provide information on the recurrence intervals of causative active faults where known prior to the earthquake. Comment is also made as to whether the surface ruptures were included in the 2010 NSHM [3] - prior to the earthquake.

Figure 2: The surface fault ruptures of the Mw7.8 2016 Kaikōura earthquake. Grey lines show the active faults of the region (from the New Zealand Active Faults Database; [21]), and the surface ruptures resulting from the earthquake are shown as red lines. The geographic name assigned to each fault rupture zone is also shown. Source of map is Litchfield et al. [5].

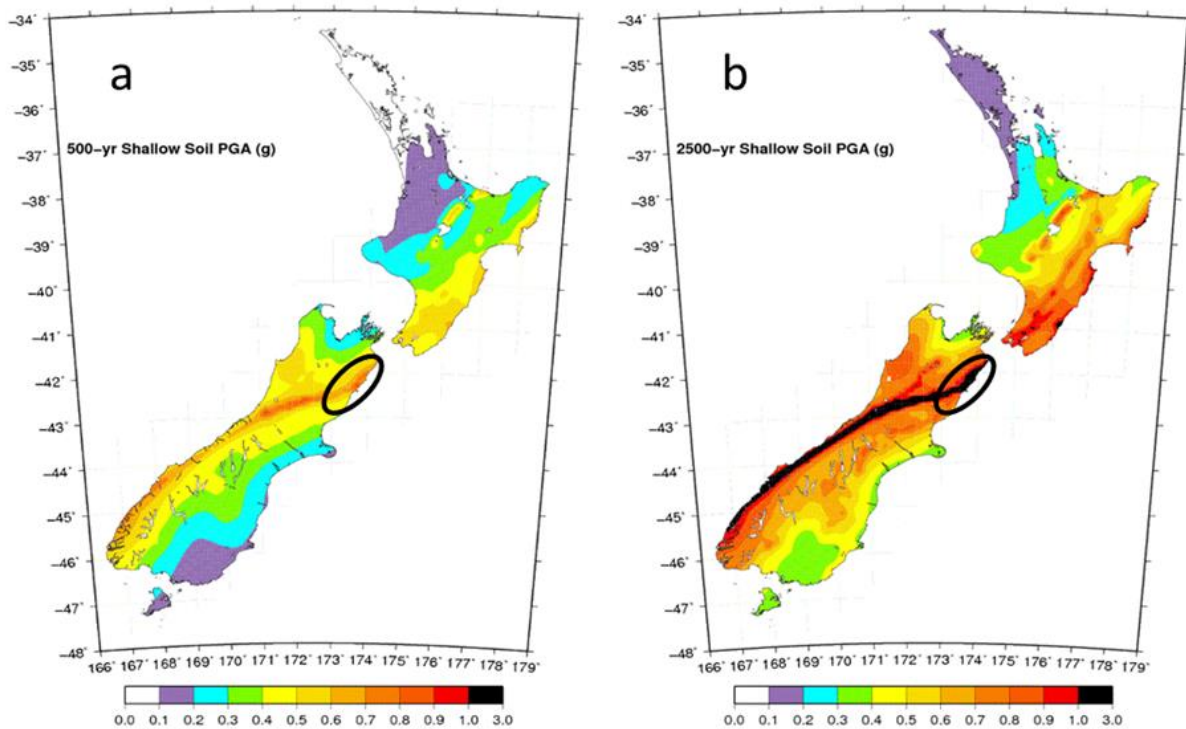
The surface fault ruptures and associated strong ground motions of the Kaikōura earthquake occurred in an area of high seismic hazard within the zone of plate boundary deformation between the Pacific and Australian plates, as shown in Figure 14 and detailed in the 2010 NSHM [3]. Specifically, the 2010 NSHM-derived peak ground accelerations (PGAs) are in the range of 0.5-0.9 g for the 500 year return period, and over 1 g for the 2500 year return period (area inside circle in each map in Figure 14). These return periods encompass the range of return periods most commonly considered in engineering applications. The maximum PGA observed in the areas of the rupture was 1.3 g in the township of Ward [12], which is consistent with the greater-than-1 g NSHM-derived motions for the 2500 year return period in the area. This is because of the high density and relatively short recurrence intervals of fault sources in the 2010 NSHM in the Kaikōura area. Furthermore, the background seismicity component of the NSHM would also have contributed to the high hazard in Figure 14 due to the high instrumental seismicity rates in the area [3].

Figure 14: Maps produced from the 2010 NSHM [3] of the PGA (units of g) expected for: (a) 500, and; (b) 2500 year return periods, for shallow soil site conditions (Standards New Zealand [37]). The black ellipses define the area of the Kaikōura earthquake, and the high hazard inside the circles can be attributed to the high density of modelled fault sources and historical seismicity in the area of the earthquake.

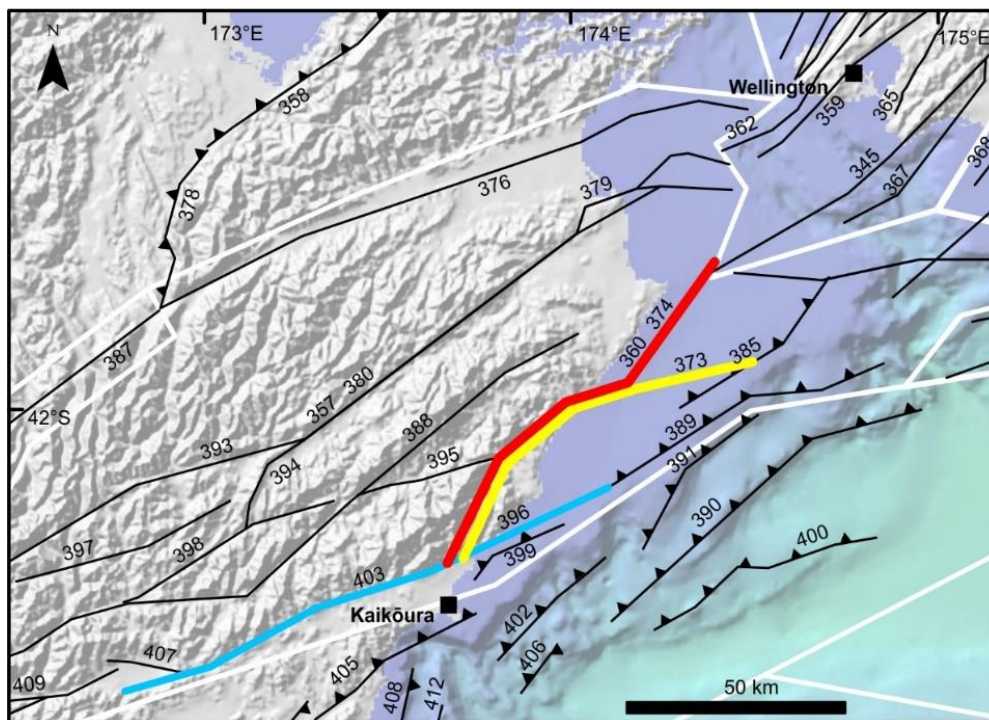
One 2010 NSHM single-fault source and one multi-fault source ruptured in the earthquake, (Hundalee Fault and Jordan Thrust-Kekerengu-Needles sources, respectively; Figures 2 and 15). This shows that the complexity of the Kaikōura earthquake rupture was in-part anticipated in the 2010 NSHM. The magnitude of the Jordan Thrust-Kekerengu-Needles source is Mw7.6 in the 2010 NSHM [3], which is insignificantly less than the Mw7.8 of the Kaikōura earthquake when uncertainties in the magnitude estimates are considered (one-sigma uncertainties of magnitude are typically $c.+0.2$ units). Inclusion of multi-fault ruptures (Figure 15) in the 2010 NSHM was an attempt to account for the high slip rates observed on relatively short faults in the area (e.g. Kekerengu Fault [38]). Also, at the time of development of the 2010 NSHM, consideration of multi-fault ruptures was generally seen as appropriate treatment of source epistemic uncertainty, given the rupture complexity of overseas events such as the 1992 Landers and 2002 Denali earthquakes. The Kaikōura earthquake surface rupture justifies additional consideration of multi-fault rupture complexity in future NSHM developments. However, we also acknowledge that the likely recurrence interval of a Kaikōura-like earthquake will be very long, implying that such a source may not be a significant contributor to overall probabilistic seismic hazard. Specifically, Litchfield et al. [5] suggest that the recurrence interval of Kaikōura events will be at least as long as the longest recurrence interval of the individual faults or fault zones involved in the earthquake (The Humps Fault, $13,000 \pm 8710$ years [23]).

Figure 15: Fault sources of the 2010 NSHM [3] in the area of the Kaikōura earthquake (black lines with numbering according to the aforementioned reference). The 2016 rupture involved the following sources: Hundalee Fault (part; labelled 405); Fidget Fault (395) and a multi-fault combination (red line) involving the Jordan Thrust (in part), the Kekerengu Fault and the Needles Fault (labelled 360 and 374; Mw7.6). Other multi-fault sources defined in the NSHM are shown as a blue line (Hope-Conway-offshore; labelled 403 and 396; Mw7.7); and a yellow line (Jordan Thrust-Kekerengu-Chancet; labelled 373; Mw7.6). Base diagram after [3].

The above shows that the existing NSHM could benefit from further efforts to develop complex multi-fault ruptures additional to those considered thus far. The approach of defining hundreds of thousands of ruptures as in the UCERF3 model for California [40] would have likely come a little closer to anticipating the complexity of the Kaikōura earthquake. Investigation of the UCERF3 source modelling methods and underlying concepts is one of the areas of research that is likely to be conducted in future versions of the NSHM. Other avenues of research are expected to focus on the development of hybrid models that better account for the geometry and activity of unmapped fault sources than do the present background seismicity models.
